# OR Annual report 2020

## Appendices

### Sewage treatment, overflows and sea water quality

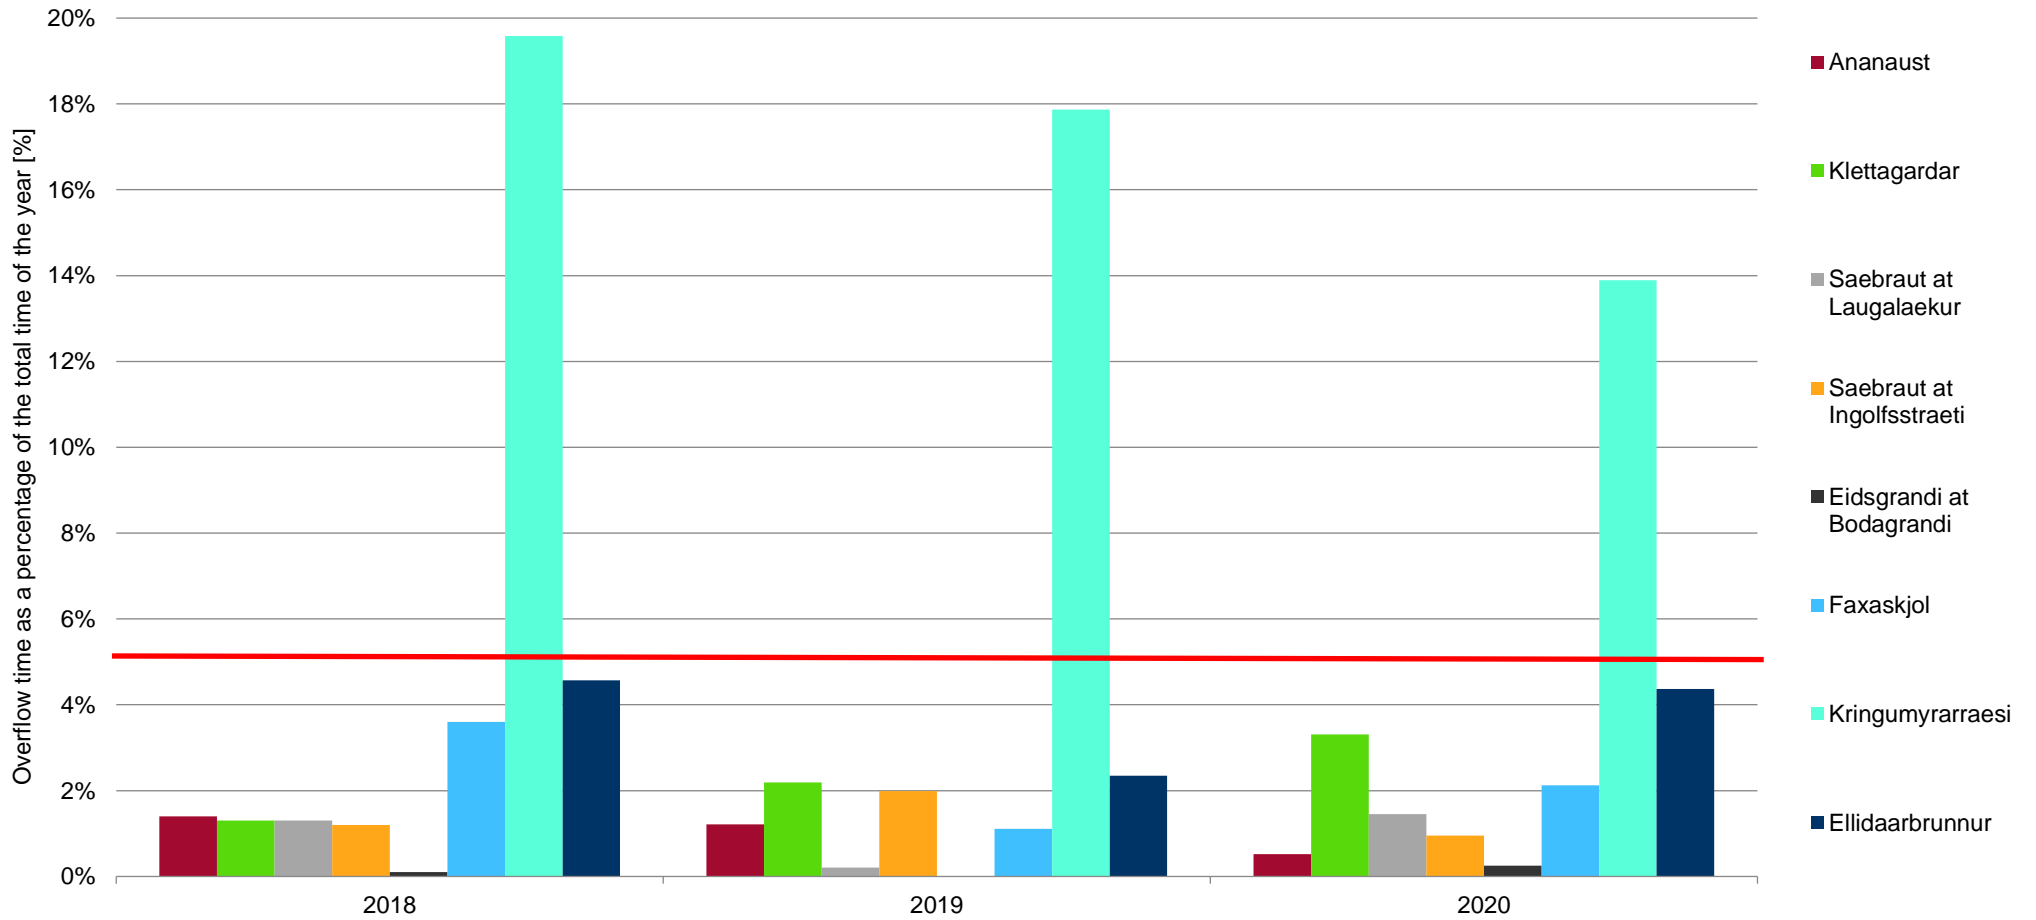
## Release via overflows in Reykjavik 2018-2020

In 2020, the discharge of effluent through Kringlumýrarræi overflow in Reykjavík was above the limits set by Veitur Utilities. According to regulation no. 798/1999 on Sewerage systems and Sewage, overflow in the sewerage system may be active for up to 5% of the time of the year, or when the sewage mixed with hot water from district heating utilities or rainwater is at least on a ratio of 1:5.

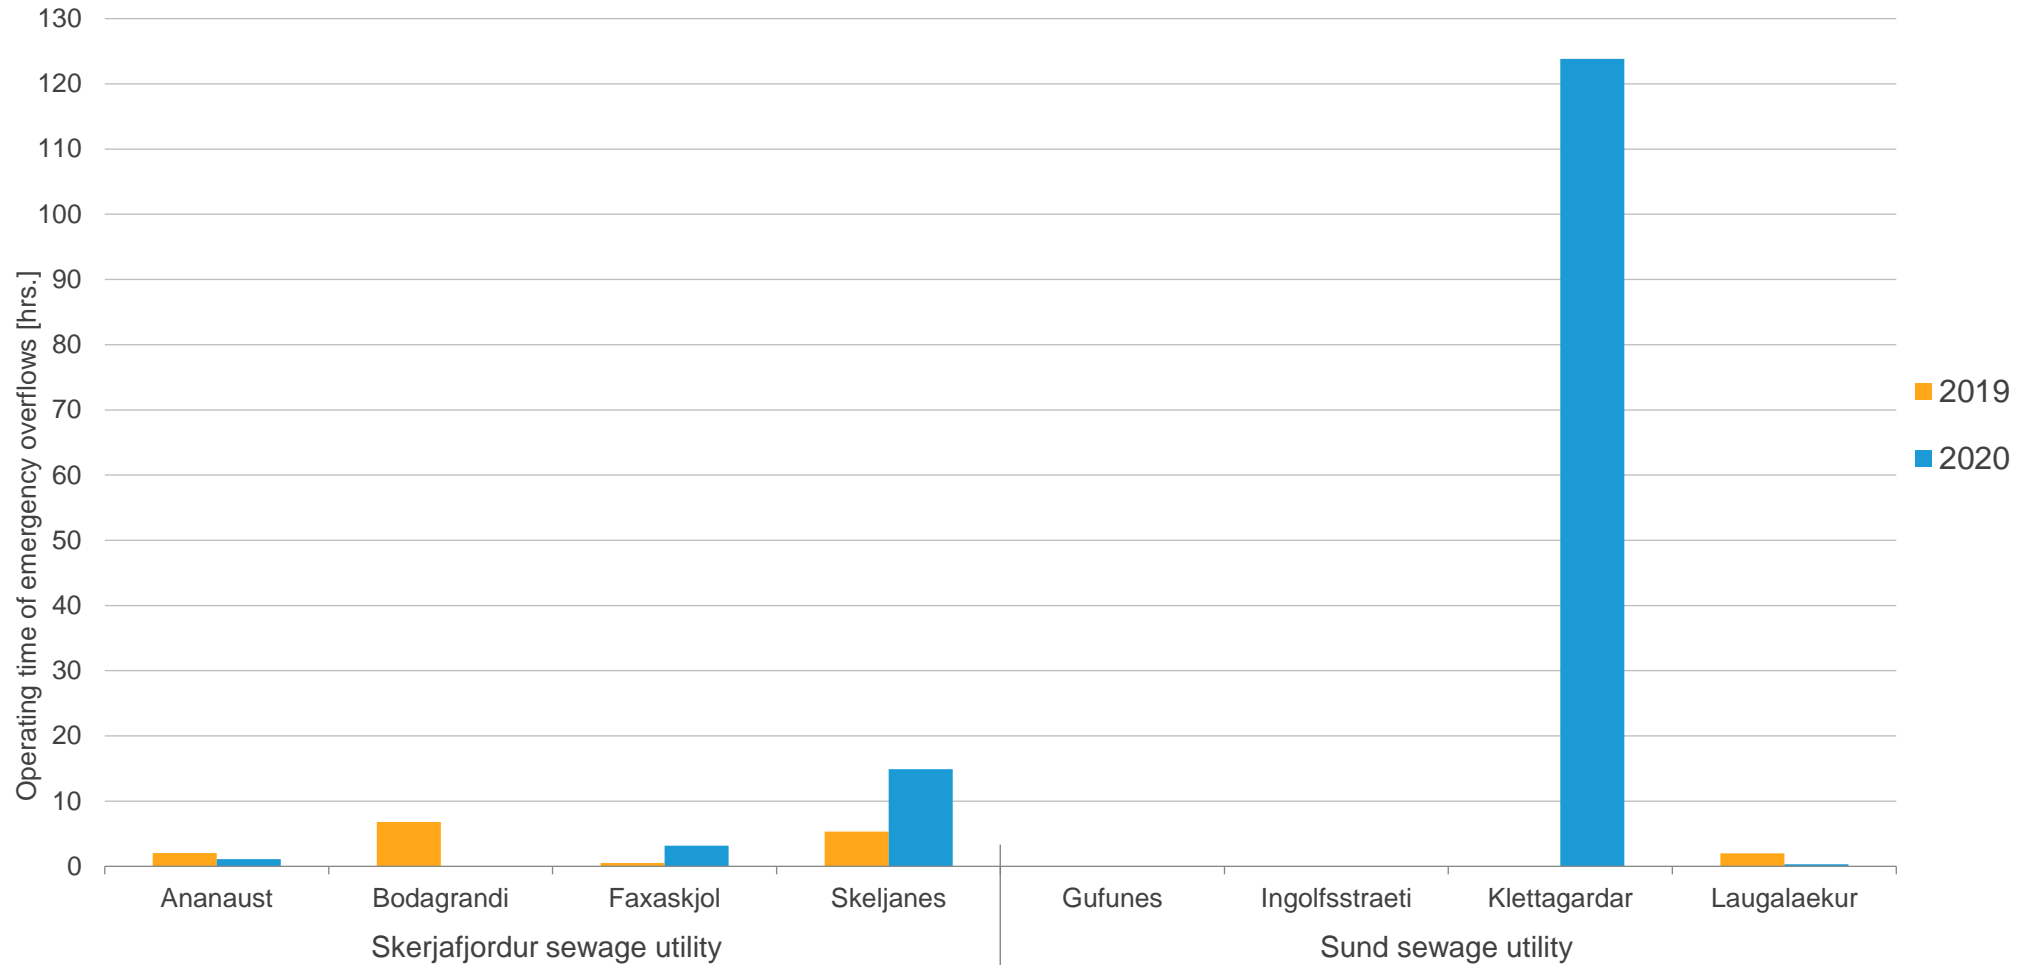
## Emergency overflow activity in Reykjavik 2019-2020

The quantity of disinfectant and wet cloths in addition to other waste in the sewerage system multiplied in 2020, resulting in a temporal inoperability of Veitur Utilities' Klettagardar sewage treatment plant with untreated sewage flowing directly to the sea via emergency overflow. Emergency overflows at Bodagrandi, Gufunes and Ingolfsstraeti were inactive throughout the year. Emergency overflows at Ananaust, Faxaskjol, Skeljanes and Laugalaekur were active for less than 15 hours during the year, which is not in accordance with Veitur Utilities' objectives, that emergency overflows should remain inactive.

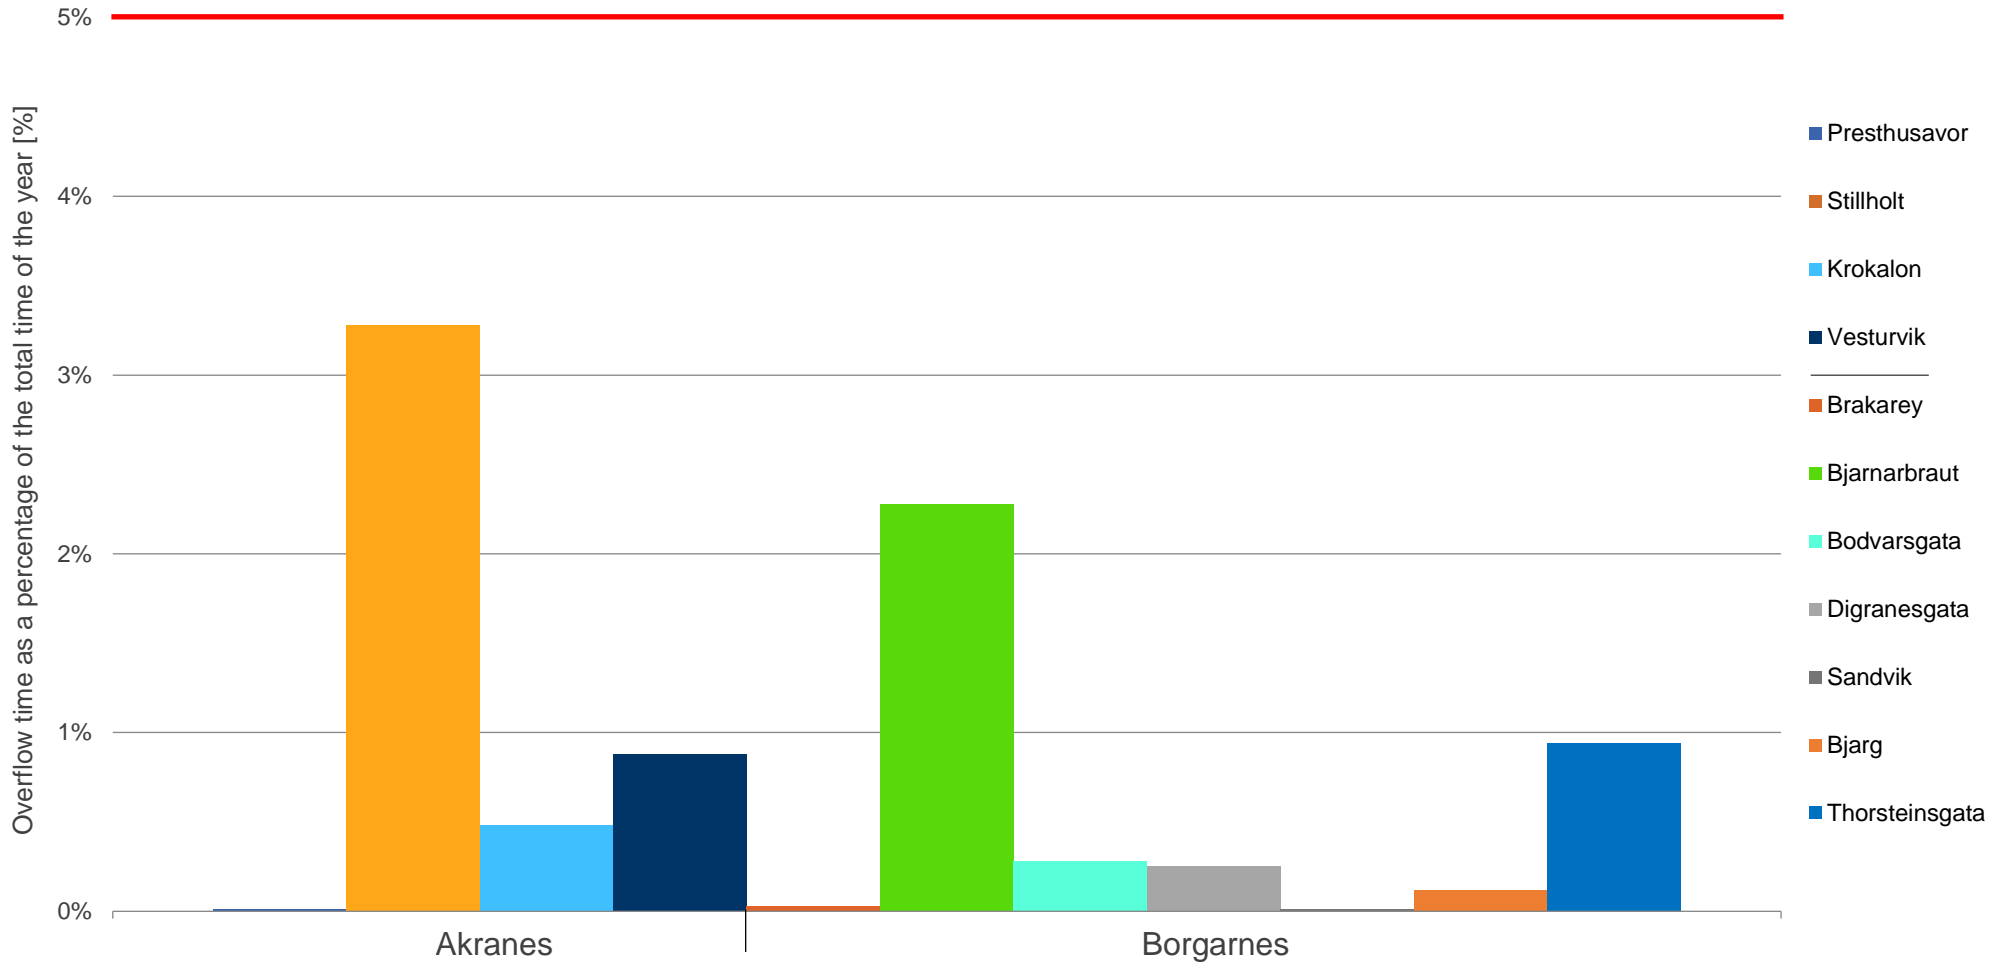
## Release via overflows in West Iceland 2020

In 2020, the discharge of wastewater via overflows in West Iceland was within Veitur Utilities' established limits. According to regulation no. 798/1999 on Sewerage systems and Sewage, overflow in the sewerage system may be active for up to 5% of the time of the year, or when the sewage mixed with hot water from district heating utilities or rainwater is at least on a ratio of 1:5. Emergency overflows in West Iceland were inactive throughout the year.
